Manhole Inspection Summary

Manhole # S07YY1020MH

Location Address: **5813 SIMMONDS AVE**

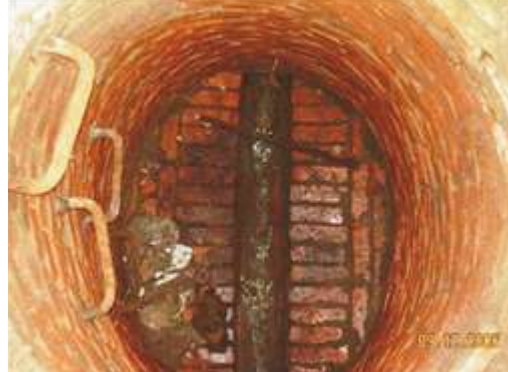
Top View

Corroded steps. Evidence of surcharge - Bench debris.

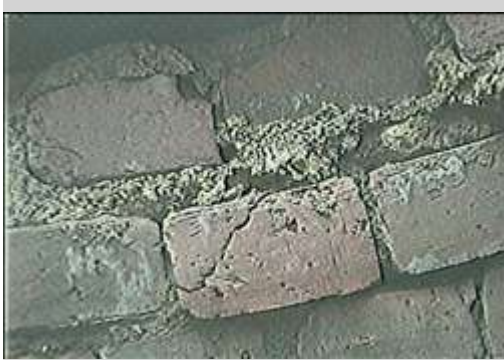
Defect

Adjustment deterioration, loose brick, cracks, and infiltration.

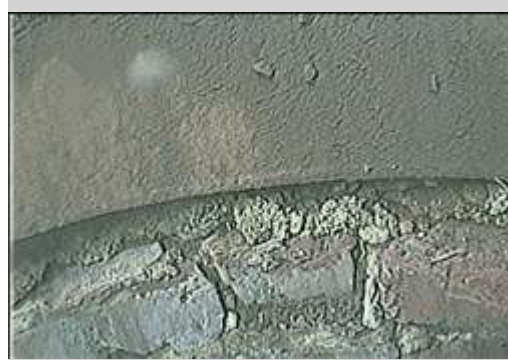
Defect

Frame leaks. Adjustment deterioration, loose brick, and infiltration.

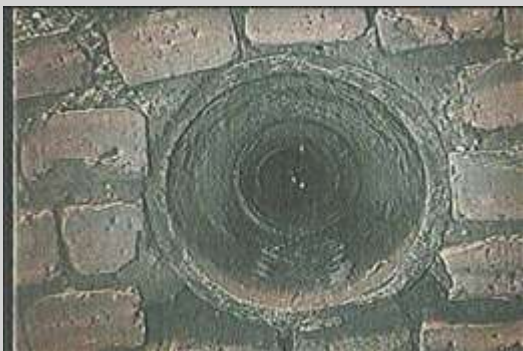
8 in. Circular Gravity Sewer Pipe In @ 6 O'Clock

Barrel deterioration and infiltration.
